Appendix A: Nunavut Airports Condition Assessments

The Department of Economic Development and Transportation retained WSP Canada Group Limited (WSP) to update the Government of Nunavut’s 2014 20-Year Capital Needs Assessment. This update serves two purposes:

- 1 To document the current condition of infrastructure at 24 airports owned by the Government of Nunavut, and
- 2 To establish a realistic needs assessment and capital renewal program to ensure the continued viability and safety of the airports.

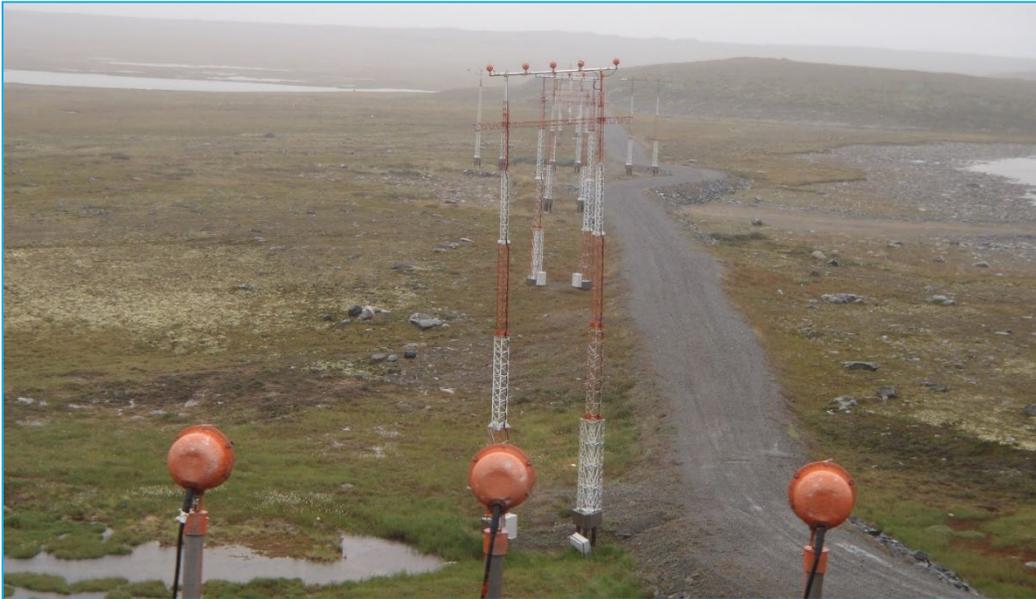
Figure 9.4 - Runway 13 Approach Lighting Rankin Inlet Airport (2010)

There are also navigation aids and weather instruments on steel towers or housed in small buildings throughout the airfield. Permafrost thaw is especially critical for these facilities in cases where navigation aids and equipment must be fixed in position to function correctly. Misalignment as a result of changing surface conditions may negatively impact their usability. Figure 9.4 illustrates the challenges of maintaining the approach lighting at Rankin Inlet.
