I am happy to share with you the "Preliminary Building Condition Assessment of Community Learning Centres by Region" report. This report provides an overview of the state of Nunavut Arctic College (NAC)'s facilities, specifically its Community Learning Centres (CLC).

This report comprises the preliminary report on the College's Community Learning Centres as prepared for the Minister Responsible for Nunavut Arctic College and the President of Nunavut Arctic College in early 2018, and forms the basis of the College's needs assessment for the renovation, modernization, or replacement of all existing Community Learning Centres as identified as a Business Priority on page *NAC-11* of the Nunavut Arctic College Business Plan, 2018-2021.

Preliminary Report
Community Learning Centres

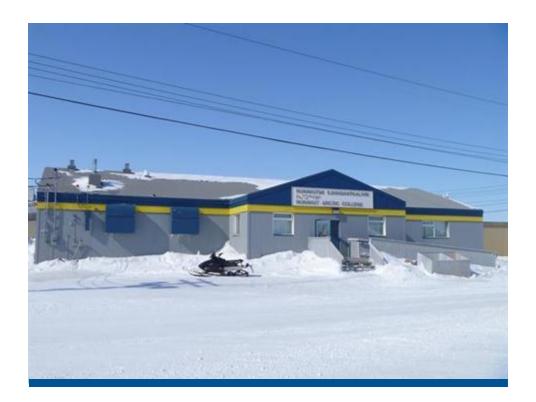
Cambridge Bay CLC - Built 1997.

Facility Assessment 2012 The site at the Cambridge Bay Community Learning Center # 2 consists of native ground cover on the south, west and north elevations of the building and a gravel surface located along the east elevation adjacent the main entrance of the building for parking, which also connects with the Hamlet roadway located east of the property. The building is accessed via wood and metal constructed stairs as well as a barrier free access ramp is provided to the main entrance. Pole-mounted transformers that deliver an overhead electrical feed to the facility are provided east of the building. Thermosyphons servicing the building are located on the north elevation. Based on information gathered and observations made by Stantec Consulting Ltd. (Stantec) on May 3, 2012, the Property components appear to be in good condition overall.

Facility Assessment 2012 The Cambridge Bay Community Learning Center # 2 is comprised of office areas, classrooms, and vocational classrooms. The building is one-story with a dirt floor crawl space constructed in 1997. The building has a gross floor area of 464 square meters. The building foundation was observed

Facility Assessment 2012 Electricity is fed overhead to the main distribution panel from a pole mounted transformer. The 120/240 V 200 A three phase main distribution panel is located in the boiler room. Power is distributed to floor level breaker panels located throughout the building. Interior lighting is supplied by T-8 fluorescent fixtures in classroom, offices and corridor spaces. Battery operated emergency lighting is located strategically in the building. Exterior lighting is provided by wall mounted fixtures. The building is monitored for fire by a non-addressable fire alarm system, complete with a "Notifier System 500" annunciator panel, pull stations, and heat and smoke detectors. Miscellaneous electrical systems include a wired data network, security and telephone systems. Based on information gathered and observations made by Stantec Consulting Ltd. on May 2, 2012, the electrical components appear to be in good condition overall.

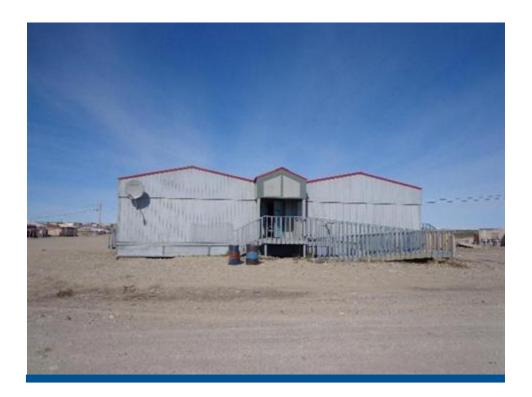
Gjoa Haven Trailers - Built in 1978 and joined in 1994.

July 2012 - The site at the Portable Classroom consists of gravel surfaces located on the building perimeter, which also connect with the Hamlet roadways that are located adjacent to the property. Pole-mounted transformers that deliver an overhead electrical feed to the facility are provided.

July 2012 - The Portable Classroom is a single-story educational services building constructed in 1978. The building has a gross floor area of 169 square meters. The building foundation was observed to consist of on-grade wood supports. The building is a wood framed structure. The exterior walls consist of painted wood panels. The roof system of the building consists of a metal roof assembly constructed over a wood roof deck. The building windows are double glazed and were reportedly replaced in 1995/96. The interior finishes of the building generally consist of carpeting in the classroom and office areas, with sheet vinyl composite provided in the corridors, faculty areas and washrooms. The ceiling finishes generally consist of suspended acoustic ceiling tiles and gypsum board ceilings. Interior partitions are gypsum board walls. Interior doors consist of wood doors for the offices and metal doors for the main entrances

Facility Assessment 2012 Electricity is fed above ground from a pole-mounted transformer to the main distribution panel located in the electrical room of the building. The main distribution panel is rated for 225 amps at 120/208 V. Interior lighting is supplied by both T8 fluorescent and compact fluorescent fixtures in classrooms, offices and corridor spaces. Battery-operated emergency lighting is located strategically in the building. Exterior lighting is provided by wall-mounted fixtures located at strategically around the building. All lighting is controlled manually. The building is monitored for fire by a non-addressable fire alarm system, complete with an annunciator panel, pull stations, and heat and smoke detectors. Miscellaneous electrical systems include a wired data network and a phone line. Based on information gathered and observations made by Stantec Consulting Ltd. in August 2012, the electrical components appear to be in good condition overall.

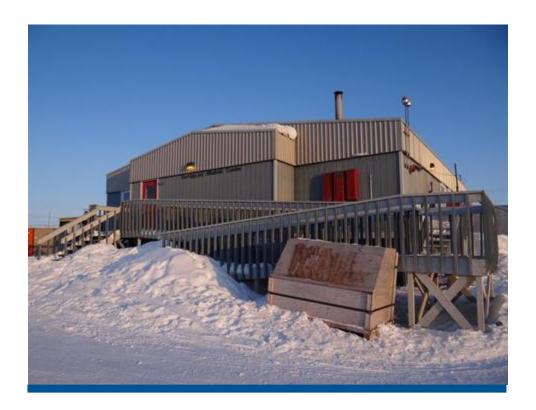
Kugluktuk - Built in 1992.

The site at the Nunavut Arctic College facility was snow covered at the time of the assessment therefore only a limited review could be conducted. However, the surrounding site appeared to include a combination of grass and gravel ground cover. There were no obvious parking areas surrounding the building.

Nunavut Arctic College Building is a single story portable structure which contains two classrooms and an office. The original building was built in 1992 and has a total area of approximately 237 sq.m (2,550 sq.ft.). The building foundation consists of steel piles. The facility is a wood framed structure and its exterior walls are covered with a combination of metal panels along the roof perimeter and wood siding along the remainder of the building elevations. The roof system of the building consists of asphalt roll roofing covering the wood sheathing deck. The building windows are awning type insulated glass units (IGUs) in vinyl frames as well as single pane portholes. The interior finishes of the building generally consist of carpeting in the classrooms and office with sheet vinyl flooring in the lobby, washrooms and utility rooms.

Facility Assessment 2012 Electricity is fed overhead to the main distribution panel from a pole mounted transformer. The 120 V, 100 A single phase main distribution panel is located in the mechanical room. 120 V is power is distributed throughout the building via a single panel board. Interior lighting is supplied by T-8 florescent fixtures throughout the building. A single battery operated emergency lighting fixture is located in the lobby. Exterior lighting is provided by three wall mounted fixtures. The building is monitored for fire by a non-addressable fire alarm system, comprised of pull stations, heat detectors and smoke detectors. Miscellaneous electrical systems include a wired data network. Based on information gathered and observations made by Stantec Consulting Ltd. on April 18, 2012, the electrical components appear to be in good condition overall.

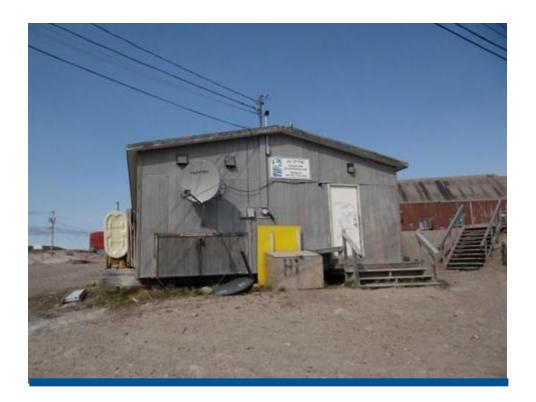
Kugaaruk -Built in 1970.

The site of the Portable Classroom consists of gravel surfaces located on the building perimeter, which also connect with the Hamlet roadways that are located south of the property. Pole-mounted transformers that deliver an overhead electrical feed to the facility are provided south of the building. Based on information gathered and observations made by Stantec Consulting Ltd. (Stantec) on July 12, 2012, the property components appear to be in fair condition overall.

The Portable Classroom is comprised of a school building. The original building is single-story with an unfinished level located on grade constructed in 1970. The building has a gross floor area of 82 square meters. The building foundation consists of wood blocks. The building is a wood framed structure. The exterior walls are wood walls. The roof system of the building consists of a roof assembly of asphalt shingles constructed over a corrugated wood roof deck. The building windows are fixed insulated glass units (IGUs), dating back to the year of construction. The interior finishes of the building generally consist of carpeting in the classroom and entryway areas with vinyl floor tiles in the washroom and mechanical

room. The ceiling finish consists of suspended acoustic ceiling tiles in the classroom and entryway areas and gypsum board ceilings in the washrooms and mechanical room. Interior partitions are drywall. Interior and exterior doors are wood doors. Based on information gathered and observations made by Stantec Consulting Ltd. (Stantec) on July 12, 2012, the building components appear to be in poor condition overall.

Facility Assessment 2012 Electricity is fed above ground to the main distribution panel from a pole-mounted transformer. The 120/208 Volts 60 Amps three phase main distribution panel was manufactured by Amalgomated Electric in 1970. Interior lighting is supplied by T-8 fixtures in the building. Battery-operated emergency lighting is located in the building. Exterior lighting is provided by wall-mounted fixture at the entrance of the building. An exit sign is installed at designated building exit. The building is provided with an emergency light fixture and a smoke detector as well. Miscellaneous electrical system includes a wired data network system. Based on information gathered and observations made by Stantec Consulting Ltd. on July 11 2012, the electrical components appear to be in fair condition overall.

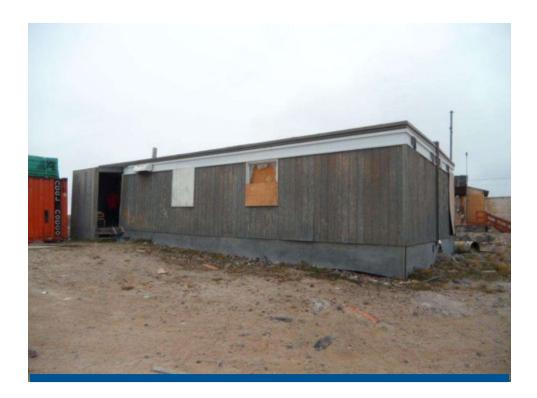
Taloyoak - Built in 1970.

The site at the Taloyoak Portable Classroom consists of gravel surfaces located on the building perimeter, which also connect with the Hamlet roadways that are located north of the property. Pole-mounted transformers that deliver an overhead electrical feed to the facility are provided south of the building. Wood framed stairs lead to the egress and entrance doors on the north elevation of the building. Based on information gathered and observations made by Stantec Consulting Ltd. (Stantec) on July 28, 2012, the property components appear to be in poor condition overall.

The Taloyoak Portable Classroom is comprised of a portable building formerly used as a classroom and currently utilized as a storage space. The building is a one-story building constructed in 1970. The building has a gross floor area of 80 square meters. The building foundations consist of wood piles supporting the wood framed structure. The exterior walls consist of wood siding. The roof system of the building consists of a metal roof assembly constructed over a corrugated metal roof deck. The building windows consist of fixed double glazed units which are original to construction. The interior floor finishes of the building generally consist of sheet vinyl flooring. The ceiling finish generally consists of gypsum board ceilings. Interior partitions are composed of painted gypsum board walls, and the interior stairs are wood framed.

Interior doors consist of wood units installed within wood frames. Exterior doors consist of metal doors installed within metal frames. Based on information gathered and observations made by Stantec Consulting Ltd. (Stantec) on July 28, 2012, the architectural components appear to be in poor condition overall.

Building comfort at the Taloyoak Portable Classroom (430-104909) is provided by an oil-fired furnace. The building is equipped by an exhaust fan in the washroom. Electrical perimeter radiators were noted along the walls, which were reportedly decommissioned when the furnace was installed. Domestic water is supplied by the community and is stored in a tank located in the mechanical room. Domestic hot water is supplied by an electric water heater manufactured by Speed-O-Matic. The plumbing fixtures in the washrooms consist of flush tank water closets and lavatories. Based on information gathered and observations made by Stantec Consulting Ltd. (Stantec) in July 28 2012, the mechanical components appear to be in poor condition overall.

Electricity is fed from the local community overhead grid to a distribution panel (rated for 50 Amps and 120/240 Amps) located in the mechanical room. Cabling and wiring distribute the electricity to various local consumers. Interior lighting is supplied by T-12 fluorescent fixtures. Interior lighting is controlled by manual switches. The building is not equipped with exterior lighting. No life safety equipment was observed at the time of assessment. The building is not equipped with telecommunication or security system. Based on information gathered and observations made by Stantec Consulting Ltd. in July 28 2012, the electrical components appear to be in fair condition overall.

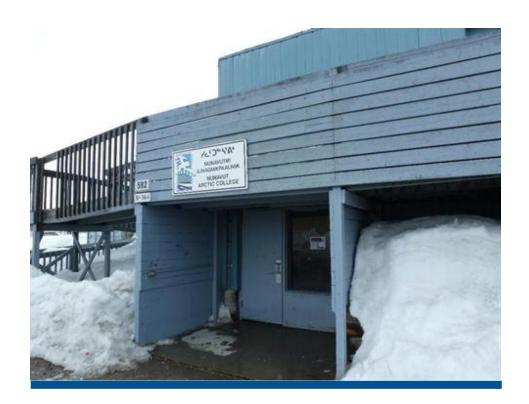
Arviat - Trailers build in 1983, joined in 1992.

The site at the Nunavut Arctic College Headquarters consists of gravel surfaces located on the building perimeter, which also connect with the Hamlet roadways. Pole-mounted transformers that deliver an overhead electrical feed to the facility are provided. Wood stairs and ramps provide access to the entrances of the building. Based on information gathered and observations made by Stantec Consulting Ltd. (Stantec) on May 10, 2012, the property components appear to be in good condition overall.

The Nunavut Arctic College (NAC) Headquarters is a two-story office building with an unfinished level located on grade constructed in 1969. The building superstructure was re-constructed in 1983. The building has a gross floor area of 670 square meters. The building was formerly the Arviat Health Center, which became the headquarters for NAC in approximately 2001. The building foundation was observed to consist of poured concrete walls. The building is a wood frame structure. The exterior walls consist of prefabricated metal panels. The roof system of the building consists of a asphalt shingled roof assembly

- Various covers for switches and plugs need to be replaced.
- The flooring is peeling in various areas.
- Several windows have broken handles and are unable to open.

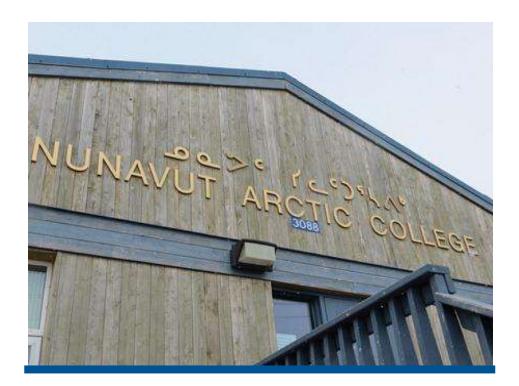
Baker Lake - Built in 2002.

The site at the Baker Lake Community Learning Center consists of gravel surfaces located on the building perimeter, which also connect with the Hamlet roadways that are located east and north of the property. Pole-mounted transformers that deliver an overhead electrical feed to the facility are provided south of the building. Wood -framed stair structures are constructed on the building's east and north elevations. A non-illuminated wall mounted sign identifies the building is provided on the east side of the building. Based on information gathered and observations made by Stantec Consulting Ltd. (Stantec) on June 01, 2012, the Property components appear to be in good condition overall.

The Baker Lake Community Learning Center is comprised of classrooms, offices and washrooms. The building is a single-story, which was constructed in 2002. The building has a gross floor area of 200 square meters. The building foundation was observed to consist of wood framing with drilled steel piles. The building is a combination of steel frame and wood frame structure. The exterior walls consist of wood siding. The roof system of the building consists of a metal roof assembly constructed over a corrugated

- Floor in Kitchen has cold spots (perhaps issues with heating system).
- Exterior Front Door to the Community Learning Centre still needs to be repaired. (CGS worked on this in the past, but there are still issues).

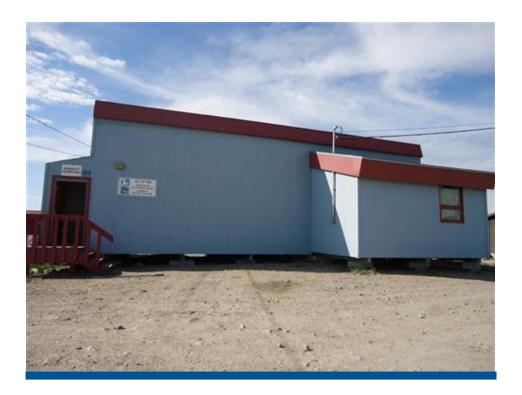
Chesterfield Inlet - Built in 1982.

The site at the Chesterfield Inlet Adult Education Building consists of gravel surfaces located on its perimeter, which connect with Hamlet roadways that are located north of the property. Pole-mounted transformers that deliver an overhead electrical feed to the facility are provided northeast of the building. Painted wood stairs are constructed at each entrance/egress door to facilitate access/egress from the building's raised main floor level. A wood-framed deck is also constructed along the building's east elevation in support of an above-ground fuel storage tank. A wood staircase provides pedestrian access to the raised wood deck from ground level.

building interior is comprised of a learning classroom and a computer laboratory. Smaller rooms on the building's east end include men's and women's single-user washrooms, a mechanical room, a storage room, and an access corridor. A small vestibule is constructed at the building's northeast corner. The addition is comprised of an office area and an adjoining storage room. Building foundations are understood to consist of wood raft footings that rest directly at-grade, which support wood shim blocks. While concealed by interior finishes, the building's superstructure is understood to be comprised of a suspended main floor structure consisting of a wood sheathed floor deck, wood joists and beams. Loadbearing wood stud framework supports the building's pitched roof structure, which is constructed in a similar manner as the suspended main floor. The building exterior is finished with painted, vertical wood slats. Exterior doors installed on the building's east and west elevations are insulated, hollow-core metal units that are hinge-mounted in painted, pressed steel frames. Window installed on north and south elevations incorporate triple-pained insulating glazing units that are set in fixed and operable (awning type) vinyl frames and sashes. Interior floor surfaces are a combination of carpeting and vinyl composite tile. Walls are primarily finished with vinyl wall covering, although smaller rooms have painted gypsum board. Ceilings are also covered with gypsum board, and are finished with either paint or a veneer plaster (stipple) coating. Interior doors are painted, solid-core wood units that are hinge-mounted in painted wood frames.

- The back door handle and lock needs to be replaced (CGS Contacted and Work order issued on May 26, 2017)
- The internet in the afternoon is almost unusable. The Galaxy Wifi does not work.

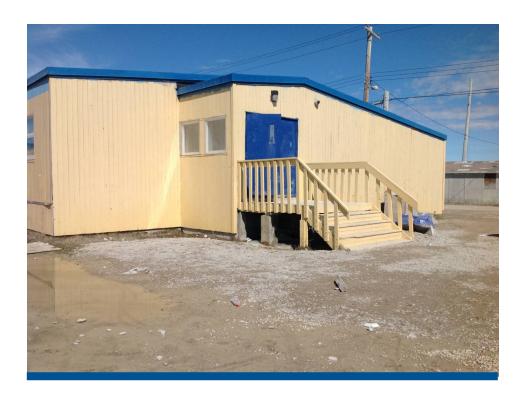
Coral Harbour - Built in 1979 as an addition to the school.

The site at the Coral Harbour NAC wing of Sakku School consists of gravel surfaces located on the building perimeter, which also connect with the Hamlet roadways. Pole-mounted transformers that deliver an overhead electrical feed to the facility are provided south of the building. Based on information gathered and observations made by Stantec Consulting Ltd. (Stantec) on June 14, 2012, the property components appear to be in good condition overall.

Stairs/steps and ramp are in fair condition. No Sign is present. Parking is located opposite to the main entrance and in of front elevation. Water was also found ponding around the building. Occasionally remove snow and debris when needed. Site around the building is fairly graded to promote the drainage

- Flooring in entrance way needs to be replaced/repaired.
- Some windows in the building have cracks and others have been repaired with Plexi Glass.

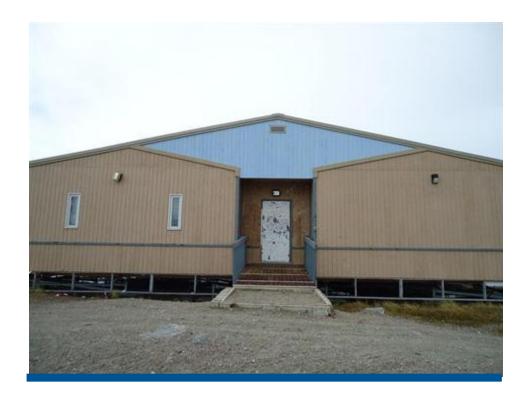
Naujaat - Trailers built in 1990, joined in 1995.

The site at the Repulse Bay - Arctic College Learning Center consists of gravel surfaces located on the building perimeter, which also connect with the Hamlet roadways that are located west of the property. A pole-mounted transformers that deliver an overhead electrical feed to the facility are provided west of the building. Based on information gathered and observations made by Stantec Consulting Ltd. (Stantec) on June 25, 2012, the Property components appear to be in fair condition overall.

The Repulse Bay-Arctic College Learning Center is comprised of an education facility. The building is a single-storey building, which was constructed in 1990 and has a gross floor area of 168 square metres. The building foundation was observed to consist of a steel piles columns supporting wood joists. The building is a wood framed structure. The exterior walls consist of wood siding. The roof system of the building consists of a metal roof assembly constructed atop a corrugated metal roof deck. The building windows are fixed Insulating Glass Units (IGUs), which are original to construction.

consist of gypsum board walls. Interior doors consist of painted wood doors in painted wood frames to the offices and fire rated doors in hollow metal frames at main entrances. Based on information gathered and observations made by Stantec Consulting Ltd. (Stantec) on June 25, 2012, the building components appear to be in fair to good condition overall. Civil Executive Summary: Facility Assessment 2016 Site drains fairly well but water ponding was found under building. Due to location of building and community road configuration there is ample parking for staff and visitors. Stairs and ramp are made of wood and in poor conditions needs complete renovation. There is presently one signage affixed on the top of the entrance of the building. Services such as heating oil, water and sewerage are being serviced by the community trucks from outside. Goods are being received and shipped from the main entrance.

- Graffiti completely covers the rear entrance
- The three exterior door seals of the building need to be repaired. Snow is getting in every winter and deteriorating flooring in entrance ways
- The ceiling in the library leaks every spring and ruins the floor. Pieces of the floor having been breaking off whenever the Janitor mops it.
- Carpets throughout the building are stained and need to be replaced.
- The exterior window pane is broken on all windows in the building. All Windows need replacing as the seals are very bad.
- The floor tiles in the hallway of the front area need to be replaced.
- Walls in the CLC need to be painted.
- Plugs in both classrooms do not have enough electrical capacity. The breakers also need upgrading.

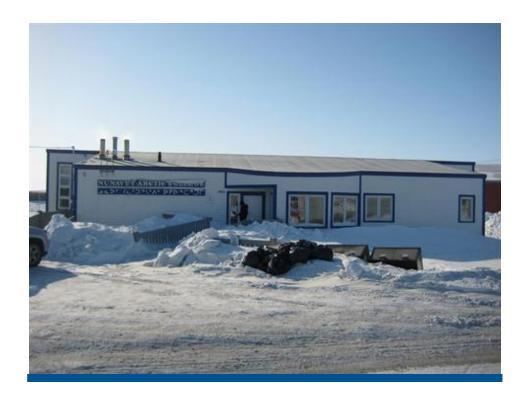
Rankin Inlet - Built in 1994

The site at the Community Learning Center consists of a gravel surfaced parking area located adjacent to the north elevation. Wood framed stairwells (complete with metal walkway/steps) are located adjacent to the entrances located on the north elevation. Based on information gathered and observations made by Stantec Consulting Ltd. (Stantec) in April, 2012, the site components appear to be in good condition overall.

The Government of Nunavut Community Learning Center consists of a one-story building. The building was constructed in 1994 with a gross floor area of 454 square meters. The building foundation consists of steel piles which support the wood framed structure of the building. The exterior walls are clad with painted wood siding throughout all elevations. The sloped roof system of the building consists of an asphalt roll membrane system. There is no drainage system in place (roof drains, gutter/eaves troughs, etc.). The exterior windows of the building consist of Insulating Glass Units (IGU's) within Polyvinyl Chloride (PVC) frames, original to construction. The floor finishes of the building interior consist of

- Light flickers in women's washroom
- Men's bathroom toilet constantly running

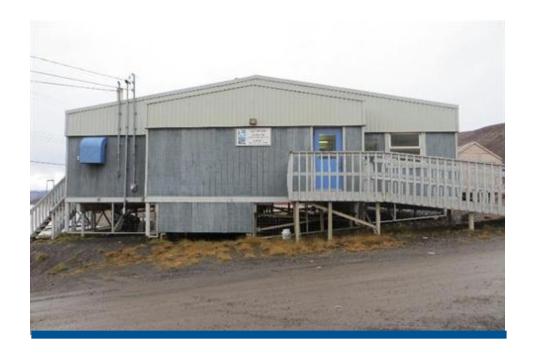
Arctic Bay - Built in 1993.

The information regarding Community Learning Center was gathered from Government of Nunavut personnel and by observations made on site by Stantec Consulting Ltd. on September 18, 2012. The site at the Community Learning Center consists of gravel surfaces located on the building perimeter, which also connect with the Hamlet roadway that is located north and east of the property. A pole mounted transformers that deliver an overhead electrical feed to the facility are provided south of the building. Wood framed ramp and stair structures are constructed on the building's east and west elevations. A wall mounted sign identifying the building is provided on the west side of the building.

- The main entrance and two back doors need weather stripping.
- The flooring in the main entrance needs to be repaired.
- The sink in the kitchen classroom freezes constantly throughout the winter, better insulation under the building is likely needed.
- A bigger water tank is needed for the CLC.

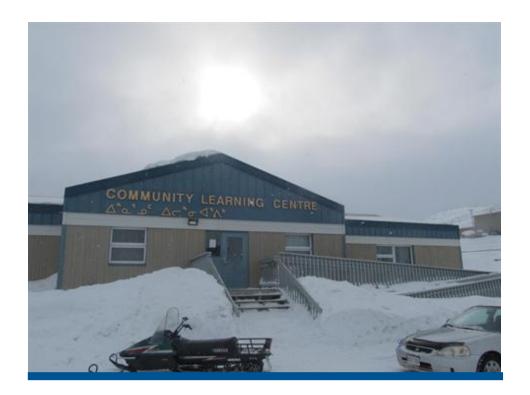
Cape Dorset - Built in 2004.

The site at the Community Learning Center consists of a building with three wood stairs providing access into the building on the North, East and West building elevations. The North elevation also has a ramp. The ramp was snow covered at the time of the assessment and was not accessible.

Electricity is fed above ground to the main distribution panel from a pole mounted transformer. The 347/600 V 400 A three phase main distribution panel is located in the mechanical room. 347/600 V is power is distributed by a motor control center to mechanical equipment. Secondary transformers provide 120/208 V power which is distributed to floor level breaker panels located throughout the building. Interior lighting is supplied by T-5 fluorescent fixtures in classrooms, offices and corridor spaces. Battery operated emergency lighting is located strategically in the building. Exterior lighting is provided by wall mounted fixtures. The building is monitored for fire by a non-addressable fire alarm system, complete with annunciator panel, pull stations, and heat and smoke detectors. Miscellaneous electrical systems include a wired data network and public address systems. Based on information gathered and observations made by Stantec Consulting Ltd. on 17 April 2012, the electrical components appear to be in good condition overall.

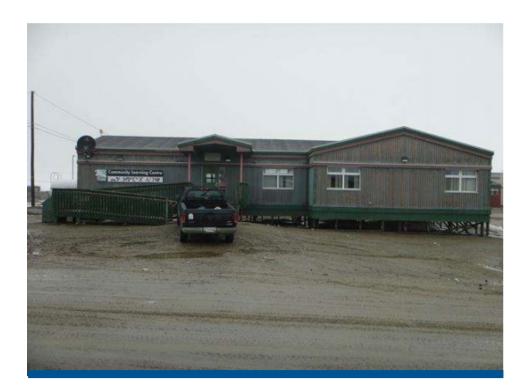
Clyde River - Built in 1998.

The site surface system at the Clyde River - New Community Learning Centre is unpaved with a dirt access road and a parking lot located at the west side of the school. Wooden stairs and ramp are constructed at the building's west / front elevation. The information regarding the Clyde River New Community Learning Centre was gathered from Government of Nunavut personnel and by observations made on site by Stantec Consulting Ltd. on June 13, 2012. In general, the Site components appear to be in Fair to Poor condition overall.

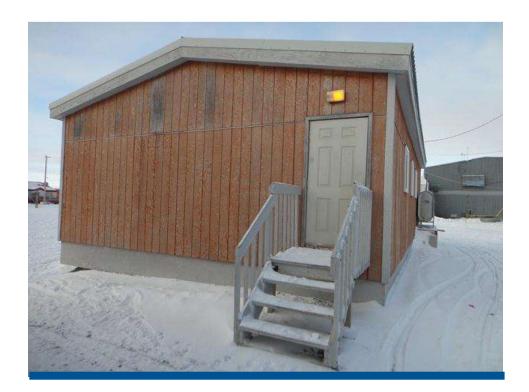
Hall Beach A - Built in 1988.

The information regarding The Adult Education Center was gathered from the government of Nunavut personnel and by observations made on site by Stantec Consulting Ltd. on October 24, 2012. The site consists of two exterior wood framed stairs which provide access to the building. Electricity is fed to the building via a pole mounted transformer.

Electricity is fed above ground from a pole-mounted transformer to the main distribution panel located in the mechanical room of the building. The main distribution panel is rated for 100 amps at 120/240 V. Interior lighting is supplied by T12 fluorescent fixtures throughout the building. Battery-operated emergency lighting is located strategically in the building. Exterior lighting is provided by wall-mounted fixtures above each entrance of the building. Lighting is controlled manually. The building is not monitored by a fire alarm system. Miscellaneous electrical systems include communication and information technology equipment. Based on information gathered and observations made by Stantec Consulting Ltd. (Stantec) on October 24, 2012, the electrical components appear to be in good condition overall.

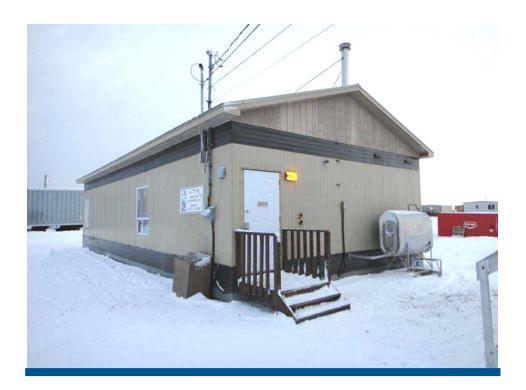
Hall Beach B - Built in 1991.

The site at the Adult Education Building in Hall Beach consists of unpaved surfaces located on the building perimeter, which also connect with the Hamlet roadways that are located to the east of the property. Pole-mounted transformers that deliver an overhead electrical feed to the facility are provided north of the building. Wood stairs provide access to the entrances at the north and south elevations. The information regarding the Adult Education Building was gathered from Government of Nunavut personnel and by observations made by Stantec Consulting Ltd., on October 25, 2012. In general, the site components appear to be in overall good condition.

The windows in the classrooms are still boarded up due to needing repairs or replacement. CGS informs us that the new windows, doors and flooring awaiting work contracts, which probably won't get done until spring / summer 2018. The existing blinds need to be replaced, the current blinds are old, torn and discolored.

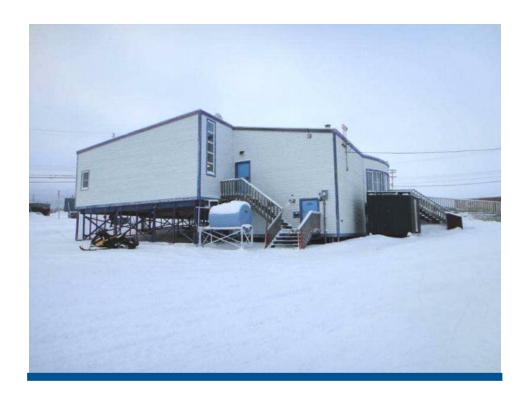
Igloolik - Built in 1995.

The site at the Igloolik Community Learning Centre consists of gravel surfaces located on the building perimeter. Pole-mounted transformers that deliver an overhead electrical feed to the facility are provided south of the building. Wood stairs and ramps provide access to the building. Based on information gathered and observations made by Stantec Consulting Ltd. (Stantec) on October 29, 2012, the Property components appear to be in good overall condition.

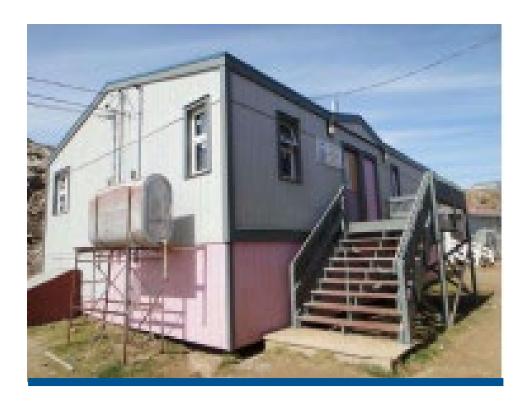
Kimmirut - Built in 1995.

The information regarding Kimmirut - Community Learning Center was gathered from Government of Nunavut personnel and by observations made on site by Stantec Consulting Ltd. on June 20, 2012. In general, the site components appear to be in good condition overall. The site at the Kimmirut - Community Learning Center consists of a wall mounted signage located at north elevation, one wood framed stair structure complete with metal stair treads located at the north elevation. A gravel surfaces are located around the building perimeter, which also connect with the Hamlet roadways.

• There are several broken windows in a variety of locations throughout the CLC. Several light fixtures are also missing covers.

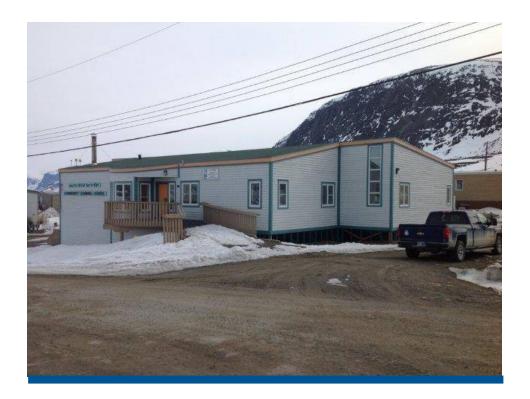
Pangnirtung - Built in 1993.

The information regarding Arctic College Community Learning Center was gathered from Government of Nunavut personnel and by observations made on site by Stantec Consulting Ltd. on May 1, 2012. The site at the Arctic College Community Learning Center consists of a wall mounted signage on the west elevation, one wood stairs at the northwest corner of the building, and one wood deck with a ramp at the main entrance, which is on the west elevation.

There has been slow leak under the sink located just outside the washrooms. The leak dripped in the cupboard under the sink which has now got mold in it. The cupboard needs repairs to remove the rotted wood.

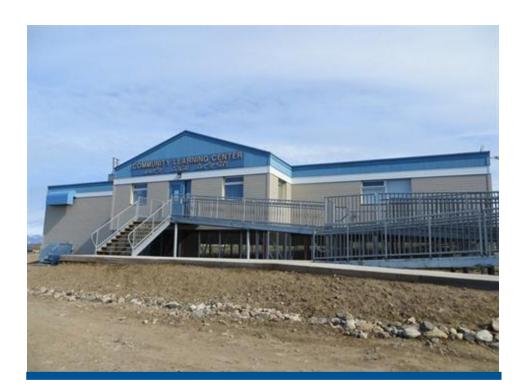
Pond Inlet - Built in 2009.

The site at the Pond Inlet Community Learning Center consists of gravel surfaces located on the building perimeter, which also connect with the Hamlet roadways that are located north of the property. Polemounted transformers that deliver an overhead electrical feed to the facility are provided west of the building. Wood framed stairs lead to the entrance and egress doors of the building. An unpaved parking lot is provided adjacent to the north and east elevations of the building. Based on information gathered and observations made by Stantec Consulting Ltd. (Stantec) on July 12, 2012, the property components appear to be in good condition overall.

Exterior doors are hollow metal doors. Based on information gathered and observations made by Stantec Consulting Ltd. (Stantec) on July 12, 2012, the architectural components appear to be in good condition

Electricity is fed above ground to the main distribution panel from a pole mounted transformer. The 120/208 V 225 A main distribution panel is located in the mechanical room. Interior lighting is supplied by T8 fluorescent lighting fixtures. Battery-operated emergency lighting and LED exit signs are installed strategically to provide illuminations and directions for exits in case of emergency. Exterior lighting is provided by wall-mounted high pressure sodium lamps. The building is monitored for fire by an EST QuickStart fire alarm system, which consists of pull stations, heat and smoke detectors. A Honeywell security system, which consists of motion detectors, door contacts and key pads, is installed in the buildings. Miscellaneous electrical systems include a wired data network and a communication system. Based on information gathered and observations made by Stantec Consulting Ltd., the electrical components appear to perform as intended overall.

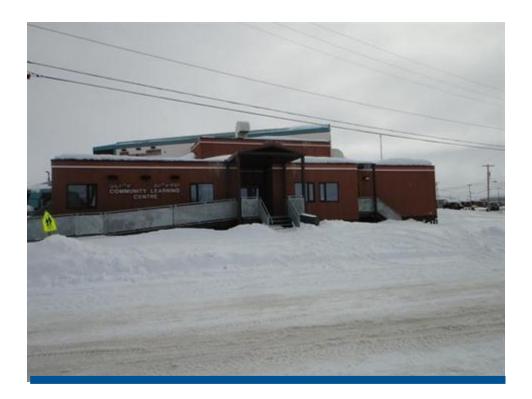
Qikiqtarjuaq - Built in 2011.

The site at the Community Learning Center at Qikiqtarjuaq consists of unpaved Hamlet roadways that are located to the north and west of the property. Pole-mounted transformers that deliver an overhead electrical feed to the facility are provided west of the building. A wall mounted sign is located on the front (north) elevation of the building. Metal framed stairs and a metal ramp provides access to the entrances of the building. The information regarding the Qikiqtarjuaq Community Learning Center was gathered from Government of Nunavut personnel and by observations made on site by Stantec Consulting Ltd. on May 9, 2012. In general, the site components appear to be in good condition overall.

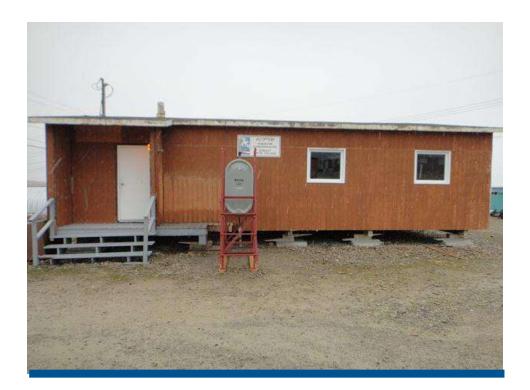
Resolute Bay - Built in 1976.

The site at the Adult Education Center in Resolute Bay consists of gravel surfaces located on the building perimeter, which also connect with the Hamlet roadway (Summer side Road) that runs parallel to the north elevation. Pole-mounted transformers that deliver an overhead electrical feed to the facility are provided south of the building. The underground utilities of the building are connected to the Hamlet's utilidor system. Wood-framed stair structures are constructed on the building's north and south elevations. The information regarding the Adult Education Center was gathered from Government of Nunavut personnel and by observations made by Stantec Consulting Ltd., on August 11, 2012. In general, the site components appear to be in good overall condition.

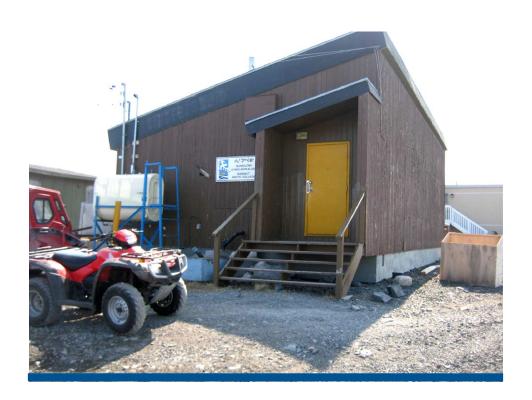
Sanikiluaq A - Built in 1965.

The site at the Sanikiluaq Adult Education consists of wood framed stairwells adjacent to the entrances located on the north and south elevations. Based on information gathered and observations made by Stantec Consulting Ltd. (Stantec) in June, 2012, the Sanikiluaq Adult Education Site components appear to be in fair condition overall.
