I am happy to share with you the "Preliminary Building Condition Assessment of Community Learning Centres by Region" report. This report provides an overview of the state of Nunavut Arctic College (NAC)'s facilities, specifically its Community Learning Centres (CLC).

This report comprises the preliminary report on the College's Community Learning Centres as prepared for the Minister Responsible for Nunavut Arctic College and the President of Nunavut Arctic College in early 2018, and forms the basis of the College's needs assessment for the renovation, modernization, or replacement of all existing Community Learning Centres as identified as a Business Priority on page *NAC-11* of the Nunavut Arctic College Business Plan, 2018-2021.

Preliminary Report
Community Learning Centres

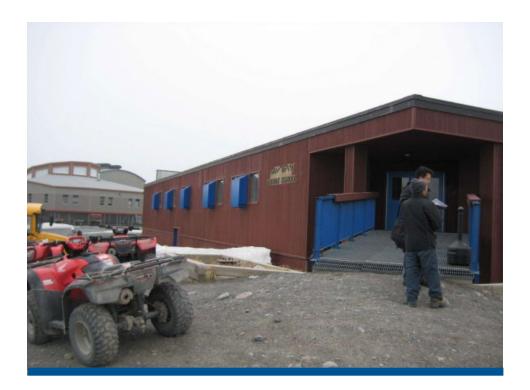
Sanikiluaq B

The College currently leases this space from the school and the lease is set to expire in 2019. The College has been made aware that this lease will not be renewed which will leave the College without adequate program space in Sanikiluaq.
